# NARCA Eagle

Volume 2016-06  
June 2016

**Don's Flight Tip #5**

### Servo Setup Issues

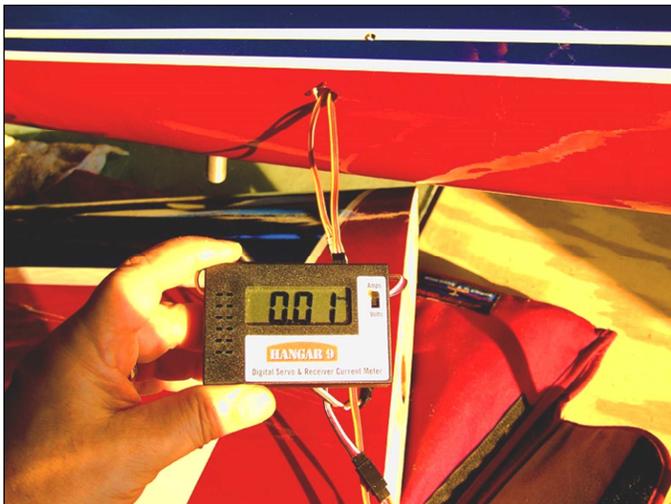
*The photo shows a current meter plugged into the receiver and a wing servo on a wing that has 2 high powered JR digital servos on the same surface. The reading shows the idle current is 10 mah indicating that there is no binding at the neutral point on this wing. The test is repeated for end points and midrange travel as explained below. Normal idle current is 10-20 mah per servo whether you are checking 1 servo or 2 or more servos per control.*

To test your setup plug the current meter between the servo and the receiver to measure the current flow to the servo as shown in the photo. One can immediately see if there is binding because of abnormal meter readings.

With your surfaces in neutral you should be reading your servos idling current. If your meter is reading more than idling current, there is a problem that will result in increased battery draw, hot or burned out servos melted wires or regulators or systems shutting down.
